ORNL/Sub/84-47992/1

**High Temperature Coating Study
to Reduce Contact Stress
Damage of Ceramics**

Final Report

Prepared by
Garrett Turbine Engine Company
A Division of Garrett Corporation
2739 East Washington Street
P.O. Box 5217
Phoenix, Arizona 85010
Under Subcontract 86X-47992C

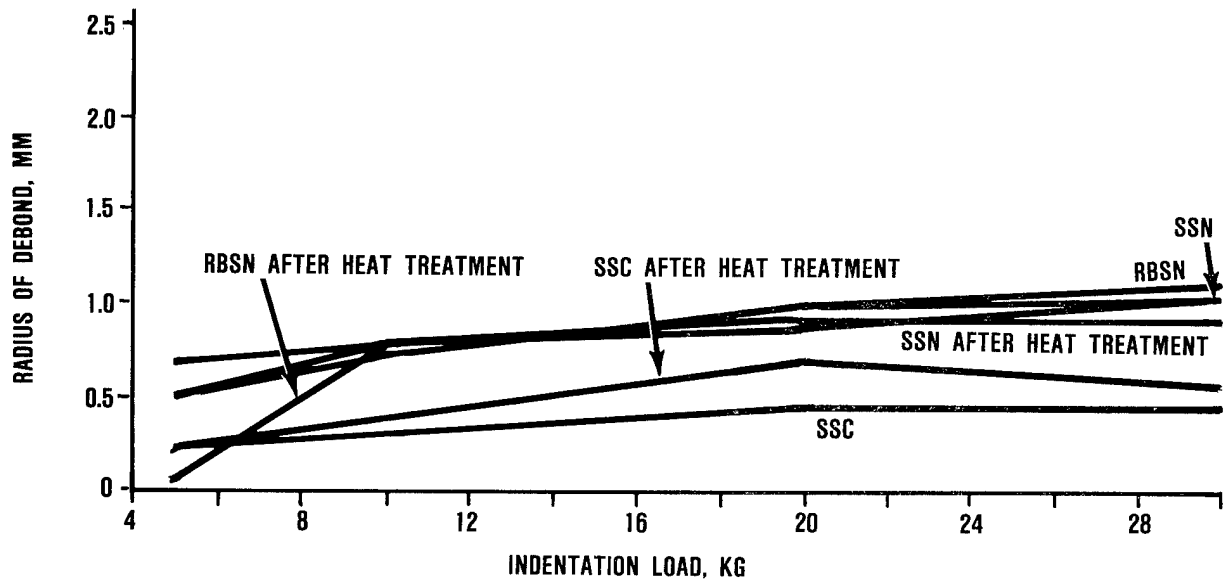
Figure 31. Laser-textured specimens exhibited excellent coating adherence before and after heat treatment. The most encouraging results were observed for laser textured SSC.

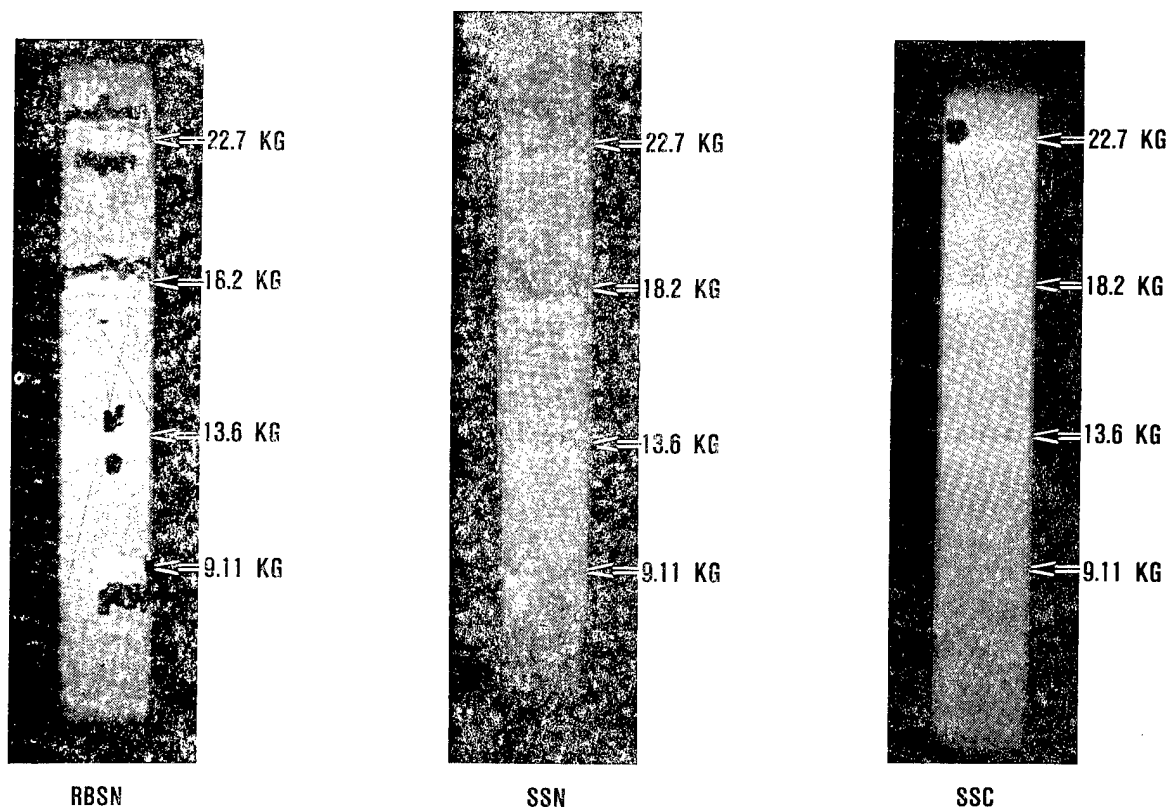
Figure 32. Contact test results on coated laser textured specimens after oxidation suggest poor adherence for RBSN and SSN and good adherence for SSC.

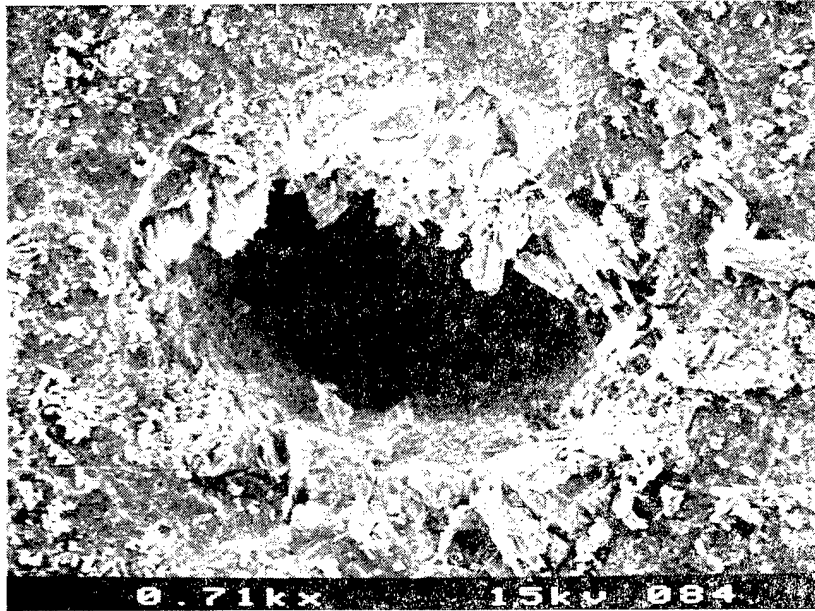
Figure 33. The EB-PVD ZrO₂ did not fill in the deep laser cavities of Si₃N₄ substrates (RBSN shown above) but only coated the cavity walls.

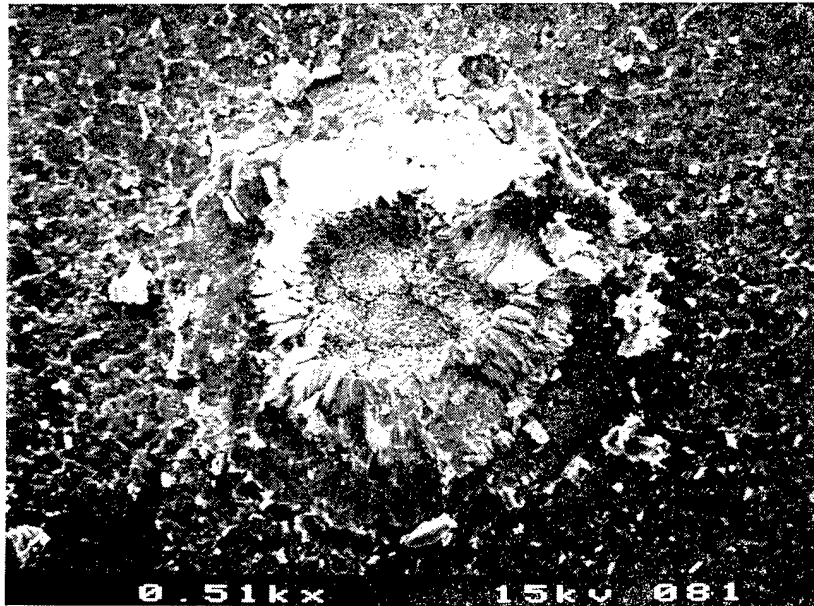
Figure 34. The EB-PVD ZrO₂ infiltrated and filled in the shallow laser cavities on SSC.

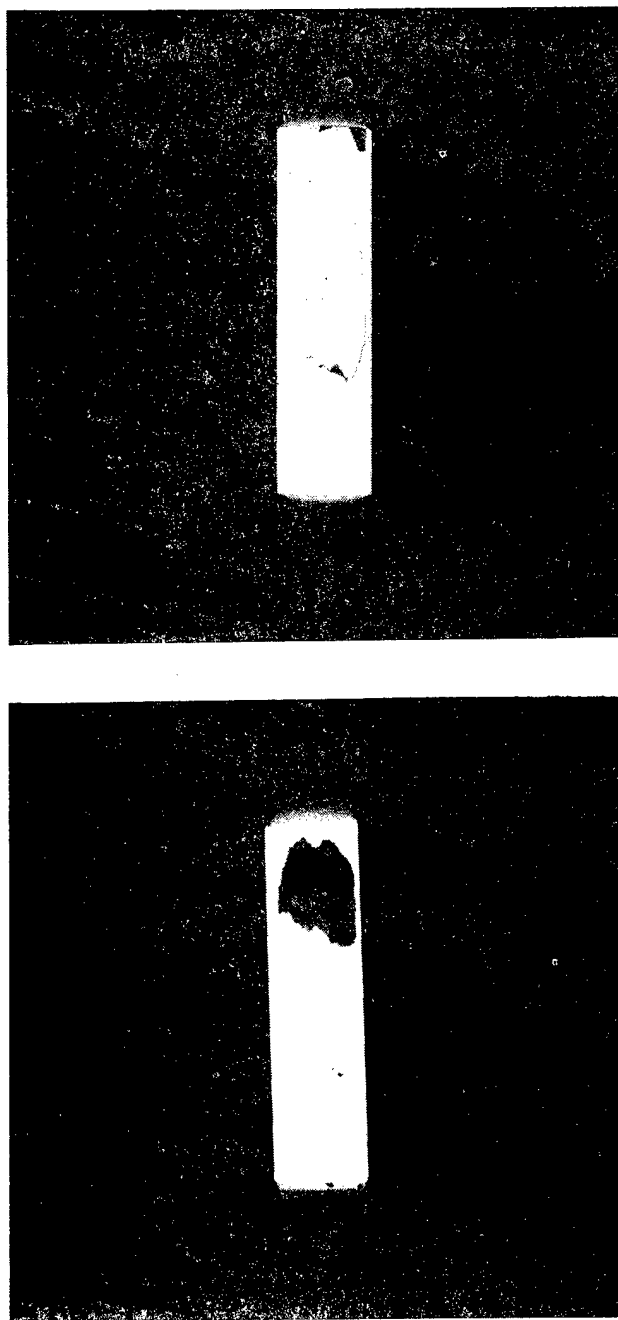
Figure 35. ZrO_2 spalling occurred on heat treatment of RBSN substrates with Ion-mixed (Ar) sputtered Al interlayers.

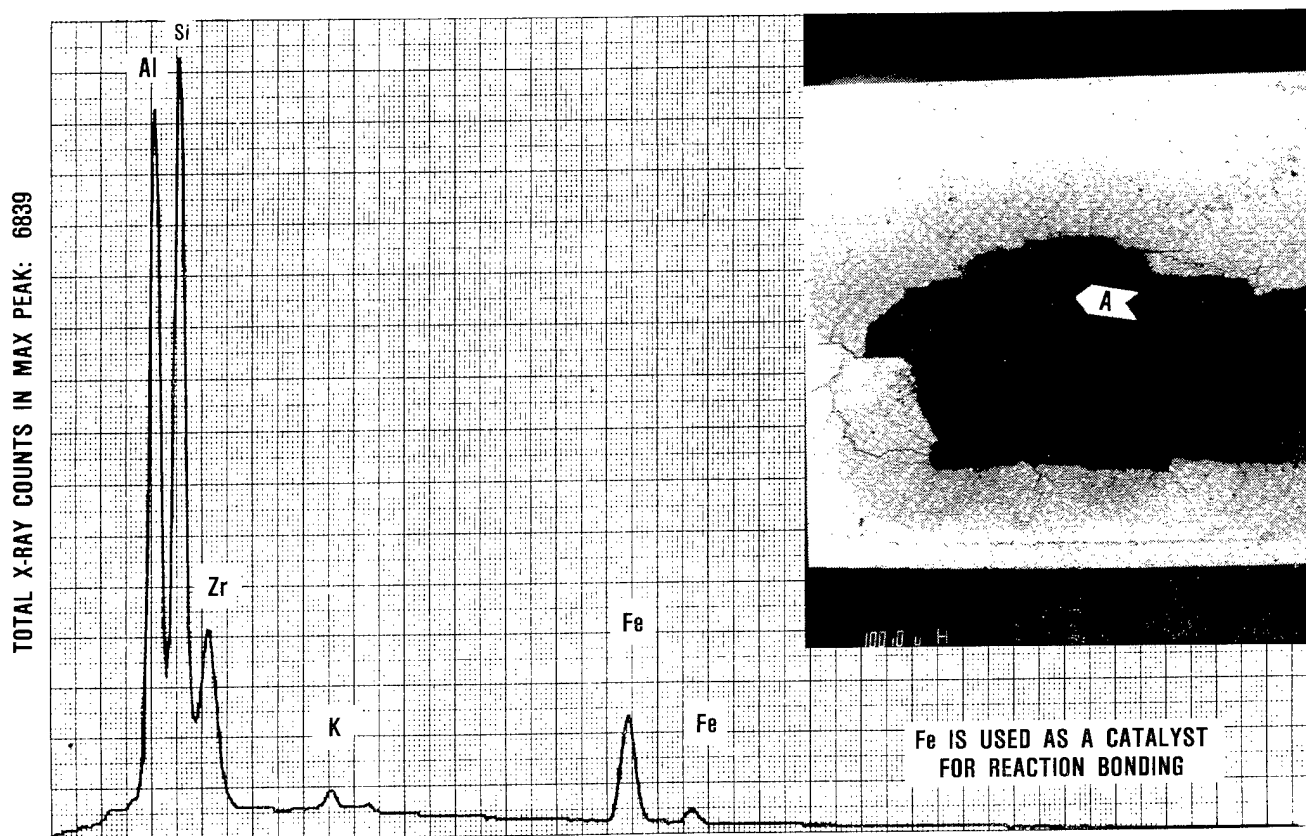
ENERGY DISPERSIVE X-RAY SPECTRUM

Figure 36. ZrO_2 coatings from run #124 spalled during heat treatment. Potassium (K) was detected in the spalled area.

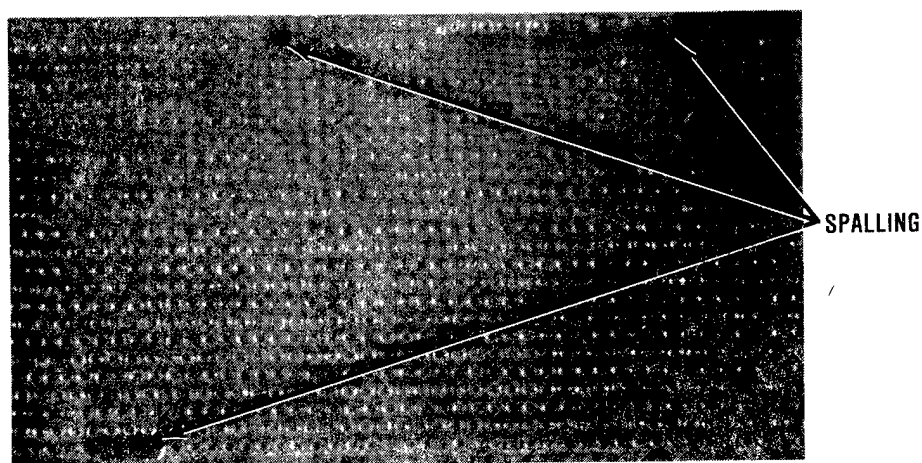
Figure 37. Laser machining of SSC substrates resulted in spalling on edges.

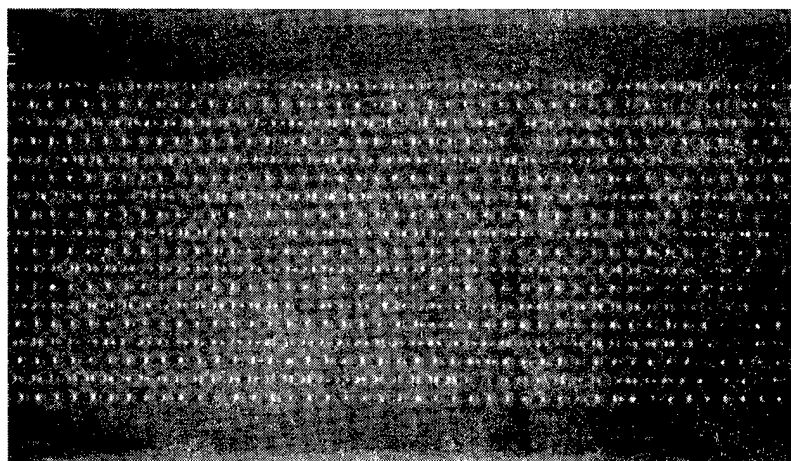
Figure 38. Some specimens were left untreated at the edges to eliminate spalling.

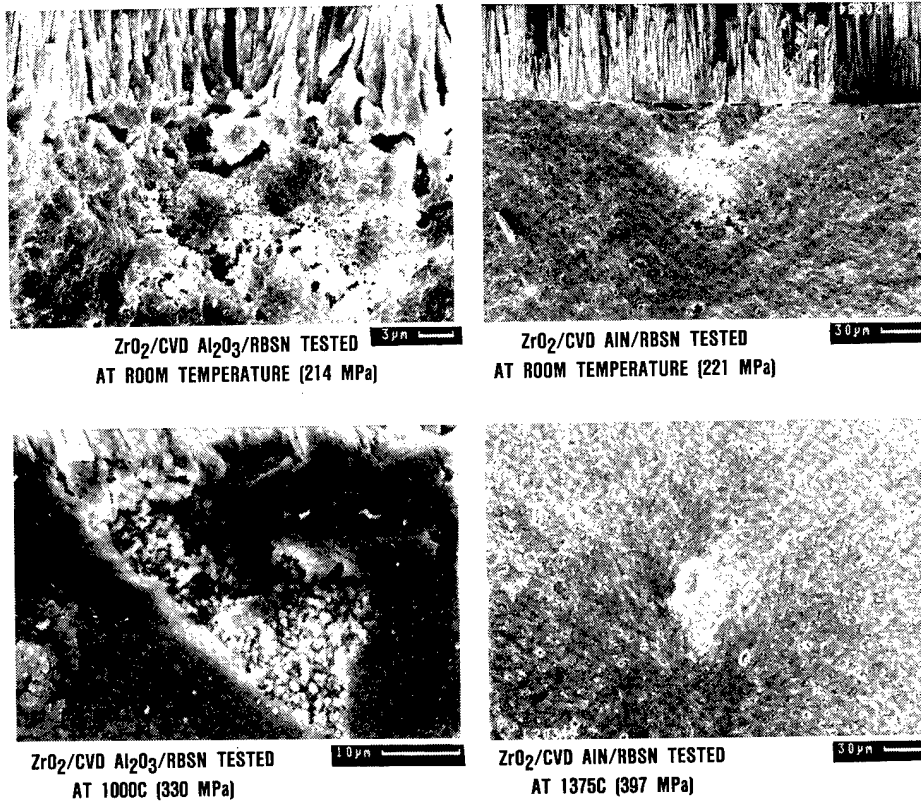
Figure 39. Both surface and internal failures for the ZrO₂/CVD Al₂O₃/RBSN and ZrO₂/CVD AlN/RBSN systems are associated with residual porosity in RBSN.

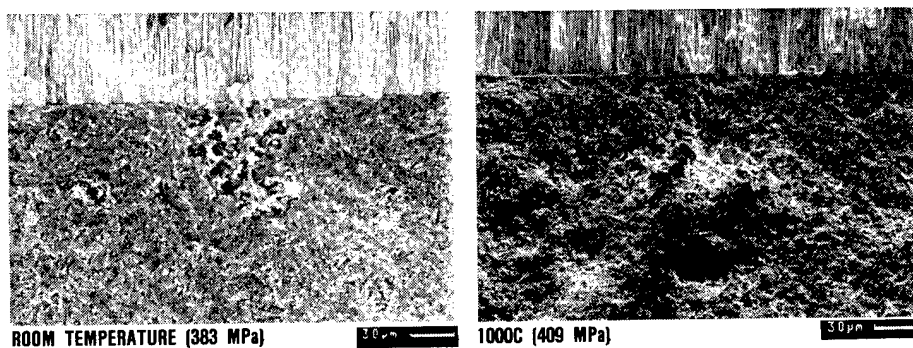
Figure 40. ZrO₂/Sol-gel Al₂O₃/SSN substrates failed primarily from large substrate flaws.

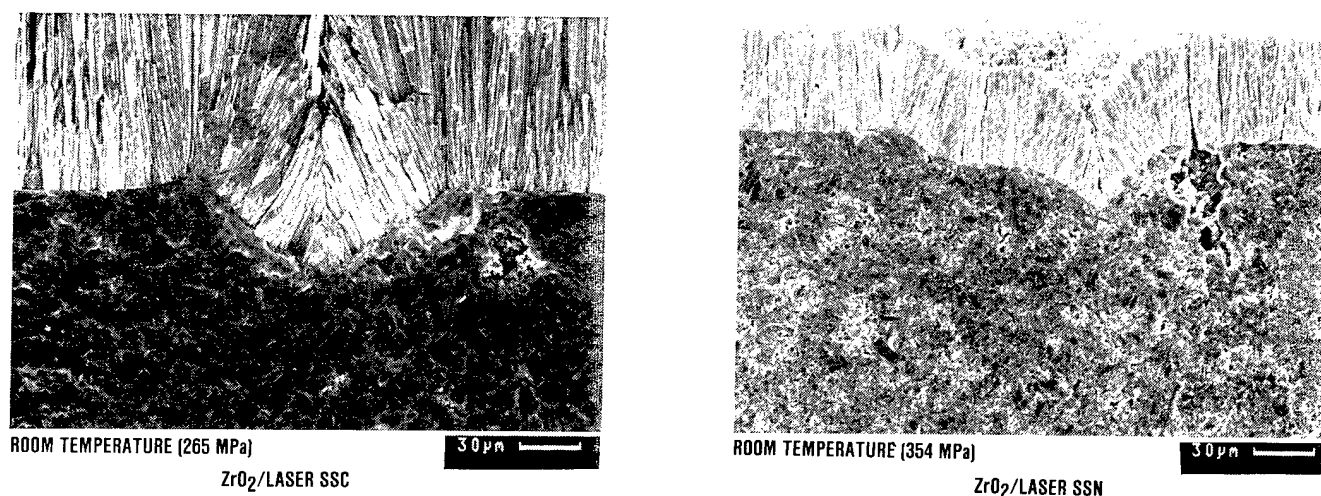
Figure 41. Failures in laser-textured specimens initiated at surface cavities on substrates.

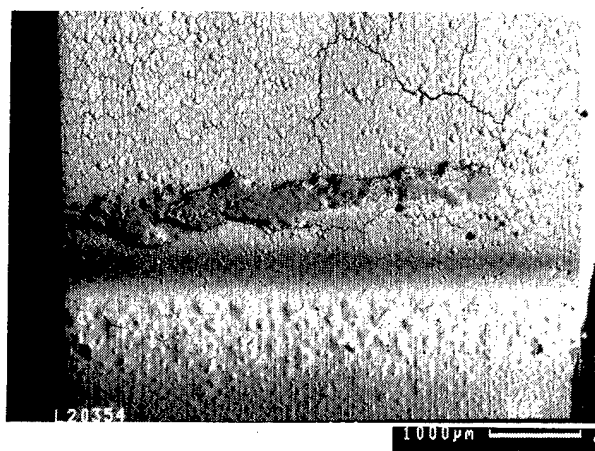
Figure 42. The EB-PVD ZrO_2 coatings exhibited glass buildup under the flexural load pins during 1375C tests.

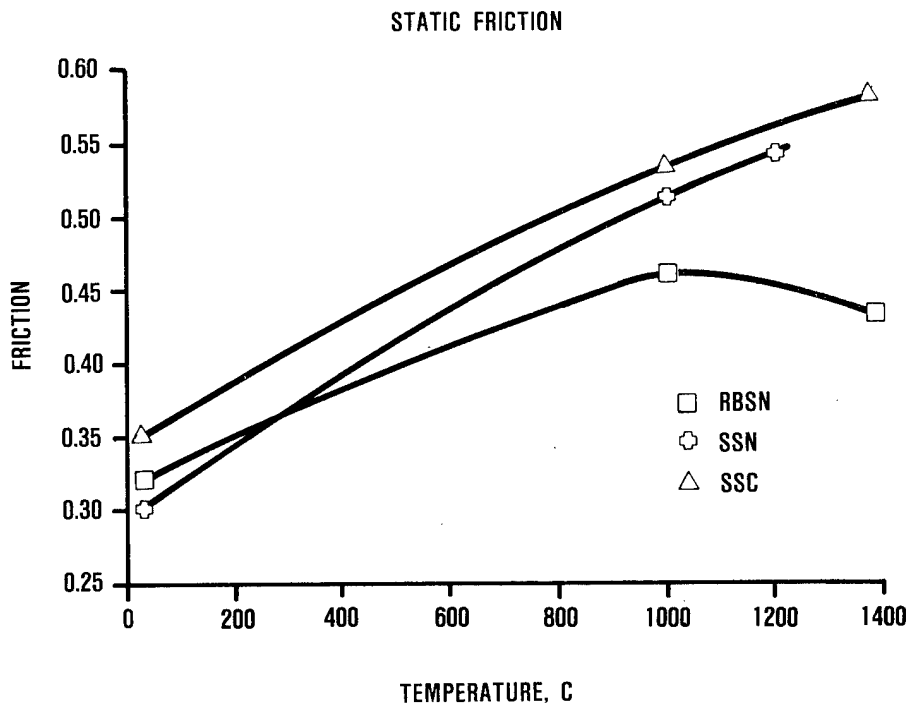
Figure 45. The static friction of RBSN, SSN, and SSC increased at elevated temperatures.

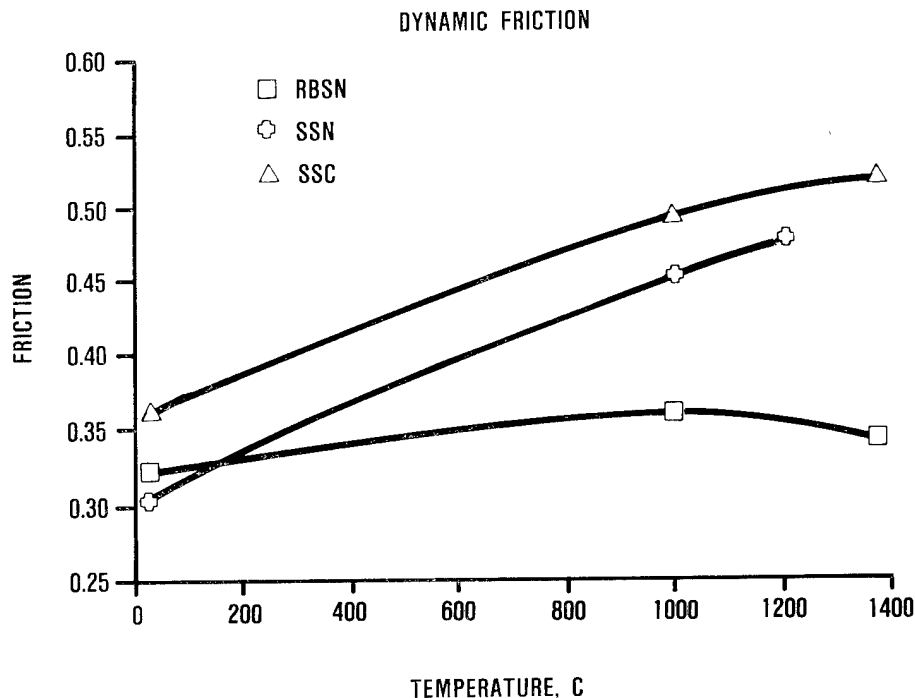
Figure 46. The dynamic friction of RBSN, SSN, and SSC increased at elevated temperatures. The increase for RBSN was minor.

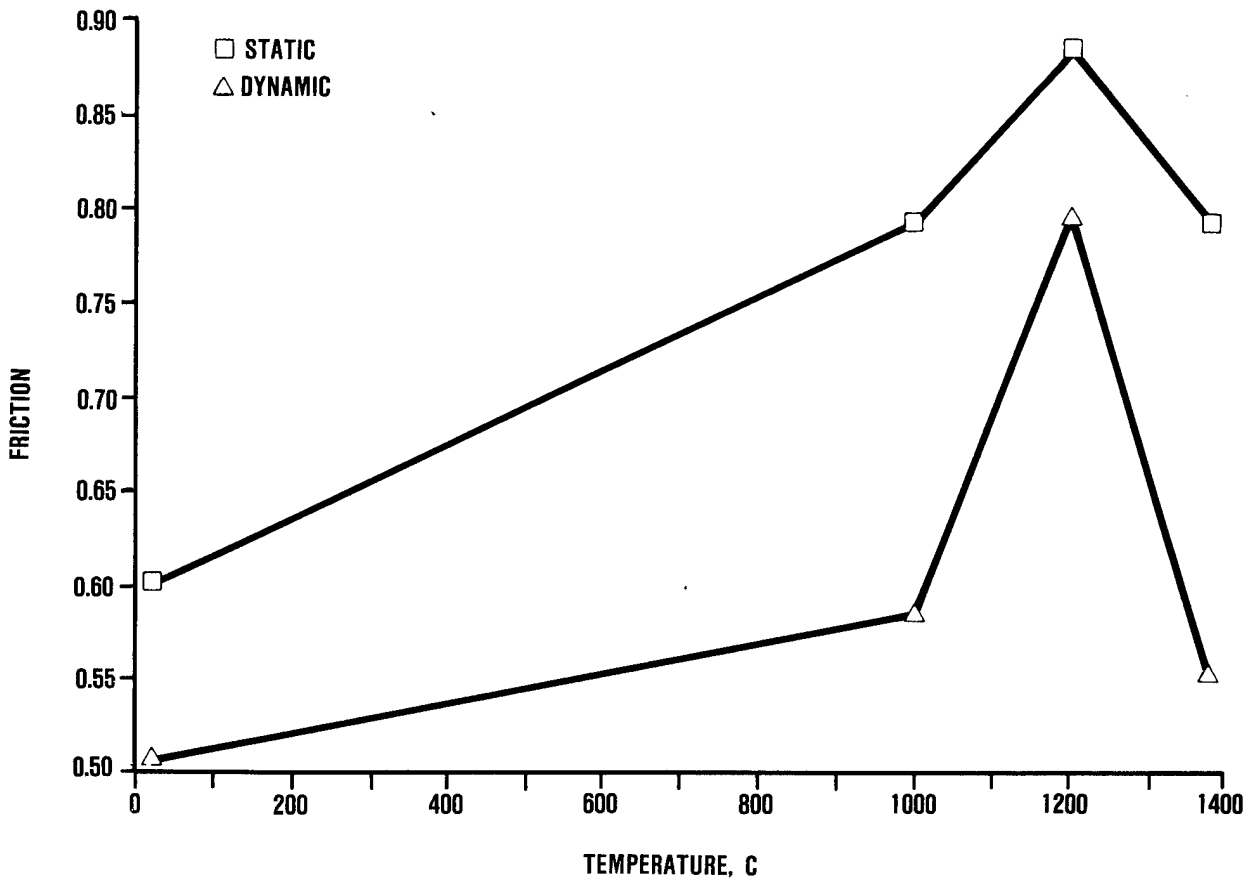
Figure 47. The EB-PVD ZrO_2 coatings exhibited high coefficients of friction during preliminary friction tests.

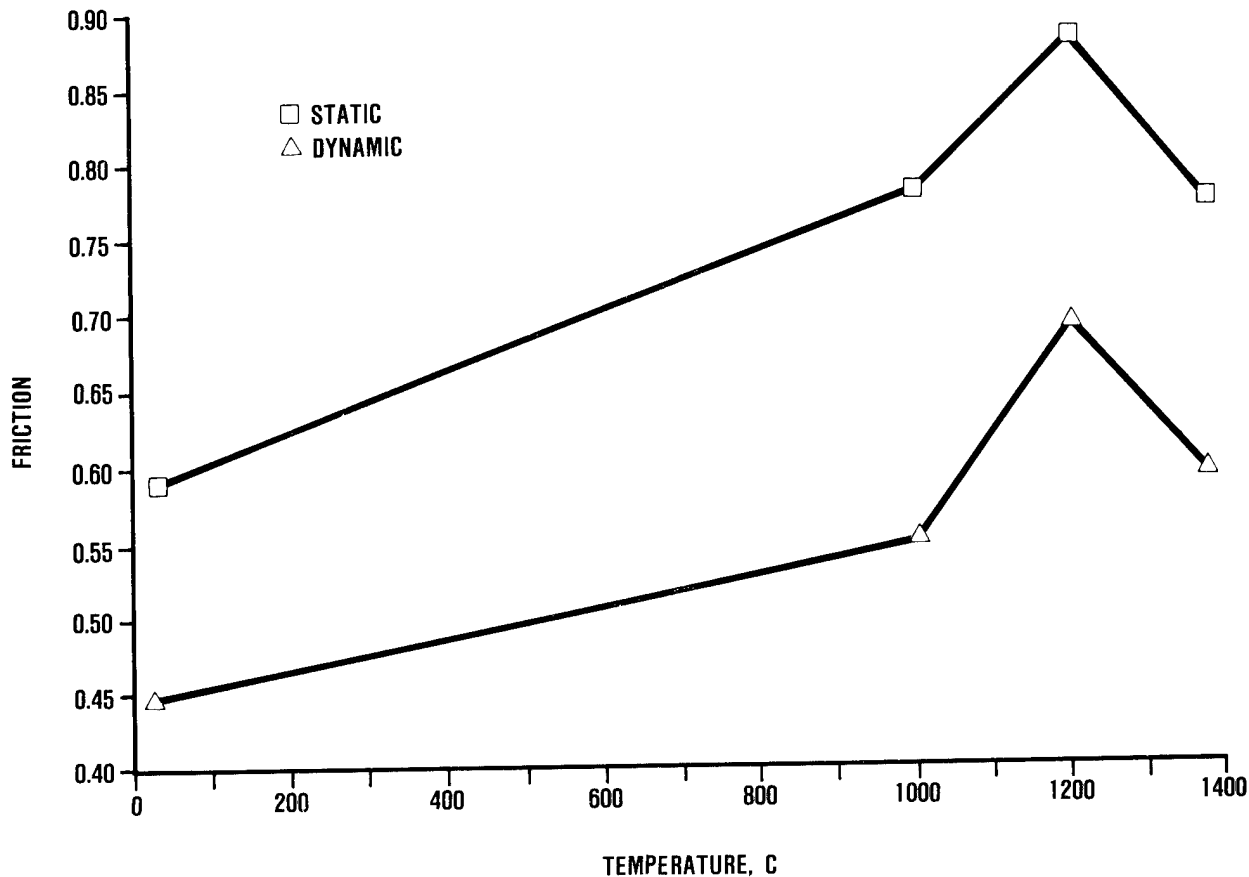
Figure 48. Friction results from contact stress tests were in agreement with the preliminary friction test results.

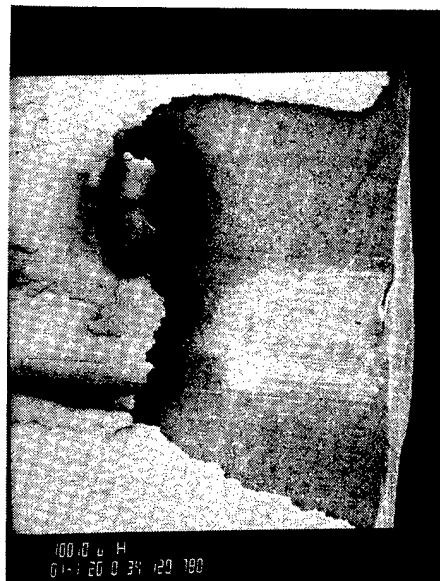
$\text{ZrO}_2/\text{SOL-GEL Al}_2\text{O}_3/\text{SSN}$

Figure 52. A large, wide crack in the SSN substrate resulting from contact stress damage caused a 50 percent strength loss.

When coating chipping occurred, the only contact damage observed was at 1200C for the ZrO_2 /sol-gel Al_2O_3 /SSN system. All ten specimens contact tested at 1200C exhibited contact damage. The damage for one specimen appeared to be more of a slow crack growth effect due to softening of the grain boundary phases in the substrate. Figure 52 shows a large, wide crack located under contact test initiation point which resulted in a 50 percent strength loss. This crack evidently grew during the 30 minute normal loading of the 45.4 kg point contact and/or the point contact displacement. The contact damage observed for the other specimens appeared to be purely mechanical and resulted in a lesser strength loss averaging approximately 10 percent. ZrO_2 /laser-textured SSN specimens were tested at 1200C under the same conditions, (i.e., 45.4 kg point contact loading) but did not exhibit any contact damage.

During 1200C and 1375C contact testing, contact damage was prevented for all systems except the $\text{ZrO}_2/\text{sol-gel Al}_2\text{O}_3/\text{SSN}$ system. All specimens from this system spalled during 1200C and exhibited contact damage. The undamaged systems also exhibited frequent spalling, although the $\text{ZrO}_2/\text{laser-textured SSN}$ had a few survivors at 1200C.
